DEPARTMENT OF TRANSPORTATION

Contract #: 04-0120F4Cty: SF/ALA Rte: 80 PM: 13.2/13.9File #: 69.15**SOURCE INSPECTION REPORT****Resident Engineer:** Pursell, Gary**Address:** 333 Burma Road**City:** Oakland, CA 94607**Report No:** SIR-001857**Date Inspected:** 05-Mar-2010**Project Name:** SAS Superstructure**OSM Arrival Time:** 700**Prime Contractor:** American Bridge/Fluor Enterprises, a JV**OSM Departure Time:** 1900**Contractor:** Zhenhua Port Machinery Company, Ltd (ZPMC), Changxing Island **Location:** Chang xing Dao, Shanghai**Quality Control Contact:** Mr. Don Walton**Quality Control Present:** Yes No**Material transfer:** Yes No N/A**Sampled Items:** Yes No N/A**Stock Transfer:** Yes No N/A**OK to Cut:** Yes No N/A**Rebar Test Witness:** Yes No N/A**Delayed/Cancelled:** Yes No N/A**Other:** Coating Inspection**Bridge No:** 34-0006**Component:** See Below**Bid Item:** 77, 78, 79**Lot No:** B#204**Summary of Items Observed:**

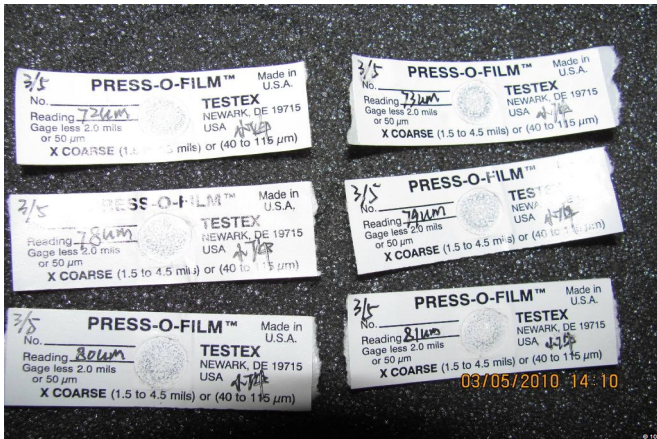
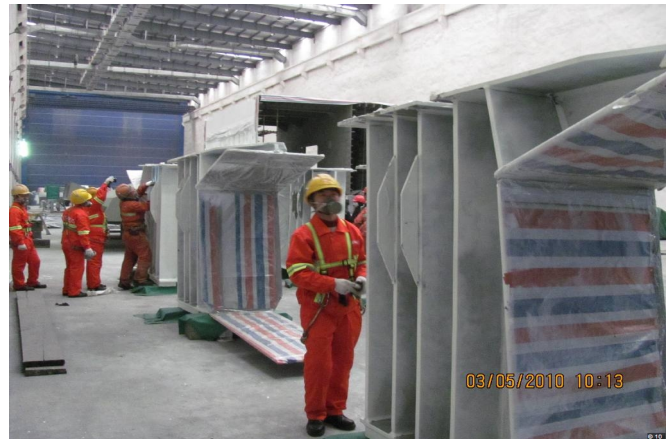
2. An inspection was requested on 6 sets of OBG Suspender bracket for the surface preparation Inspection for Finish coat application, vide inspection request no. 2795. The suspender brackets are SB 32E-1 no, SB32W- 1 no., SB34W- 1 no., SB 34E-1 no., SB30E- 1 no., SB30W-1 no. The ambient conditions during the inspection found to be 2.4 deg. above dew point and the relative humidity found to be 65.8% inside the paint shop which is not found to be within the parameters of contract documents. This Caltrans inspector observed, ABF inspectors Mr. Don Walton, Mr. Shi stone and Mr. Wei performing Ambient condition check with Dew point meter and was rejected by ABF Inspectors. International protective coatings technical service representative Mr. Li peng was found present during the course of this inspection process. The same Suspender Brackets was offered for Finish

coat Inspection again along with Cross beam (CB4) external surfaces for finish coat and Bike path (BK 001-024) external fabrication repaired areas for Blasting Inspection vide Request no. 2797. The ambient conditions were measured again and it was found not suitable for Painting as it is below 3 deg, celcius which is not acceptable as per Contract documents. (Photograph of Suspender Brackets is attached)
